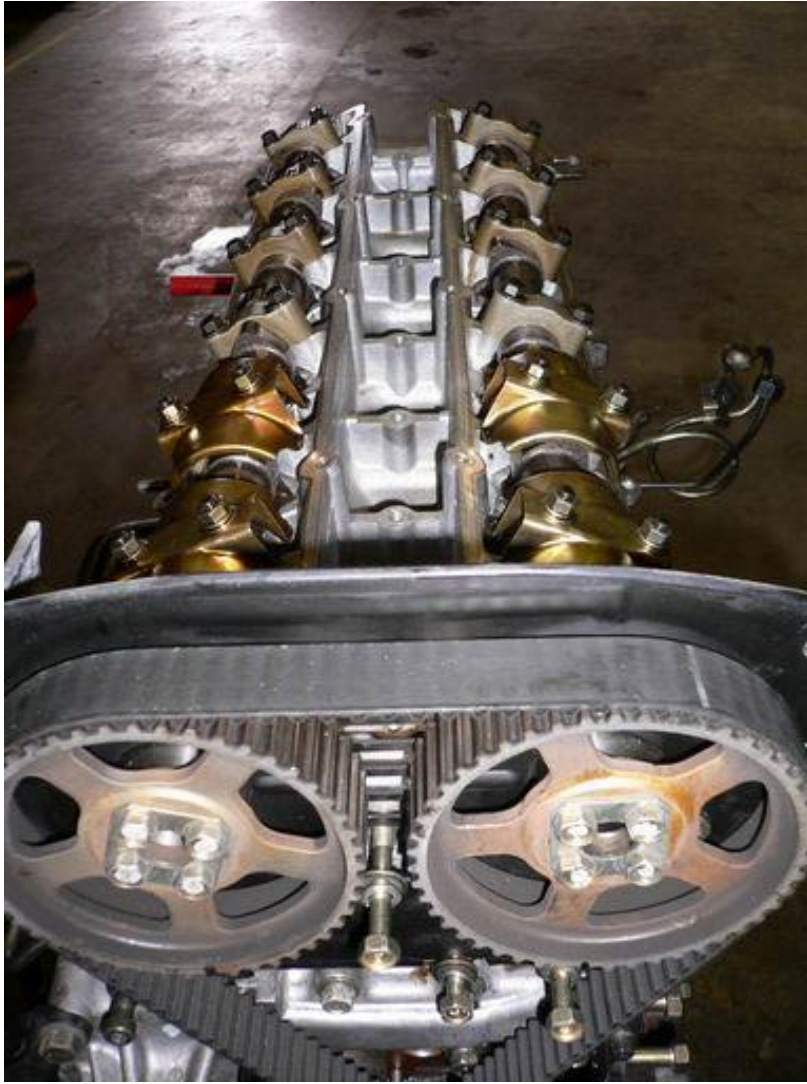
The cam covers & timing belt covers removed. Looks like a work of art! I like this photo

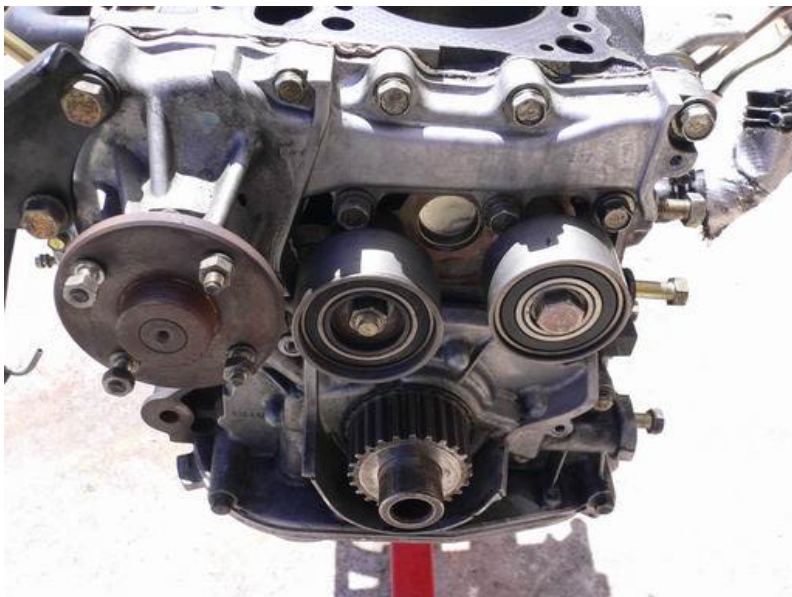
Timing belt removed, head removed, water pump still in place

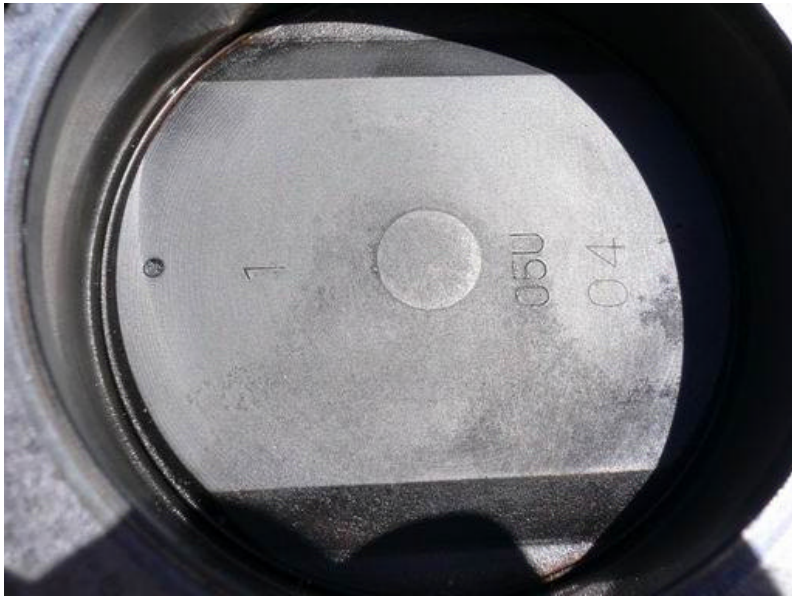
The bores, pistons were in as new condition which was an excellent find.

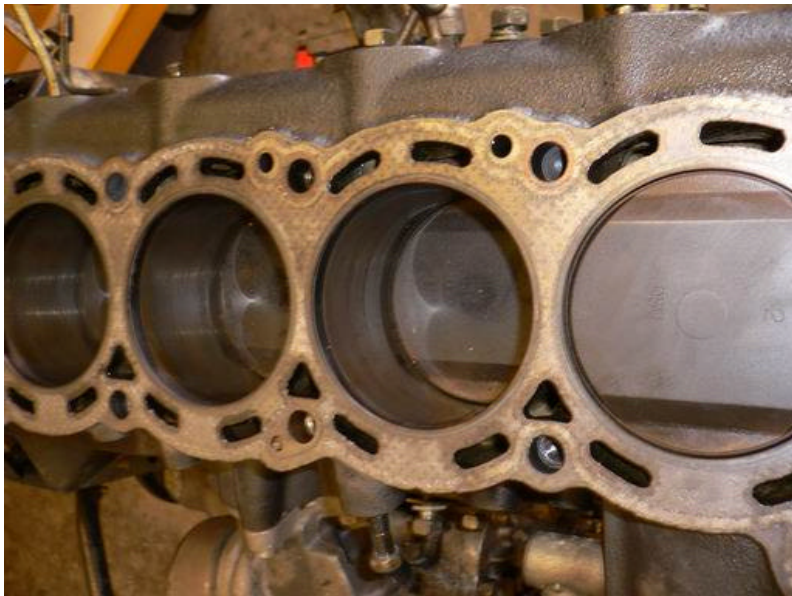
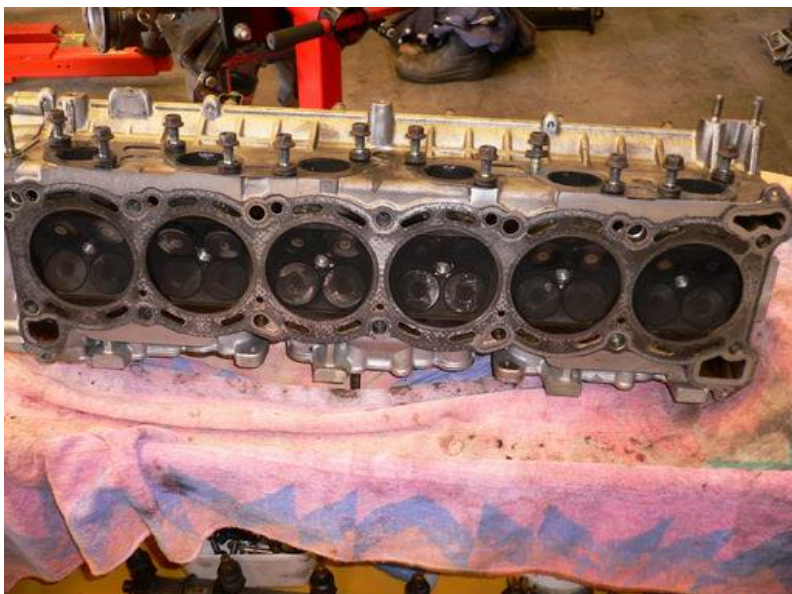
The head as it came off

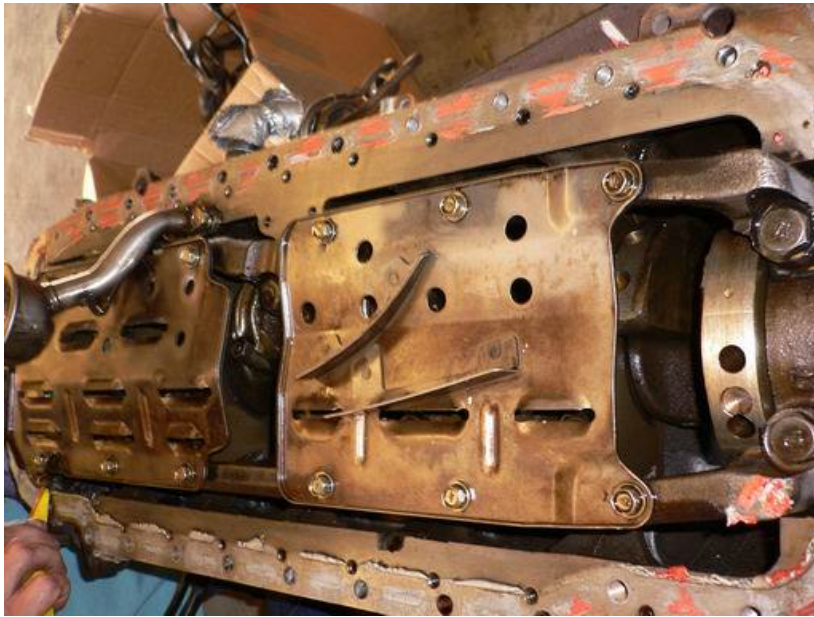
The monster alloy 4WD sump was removed. There appeared to be no water in any of the sump oil, so the cause of the mysterious sludge is no clearer

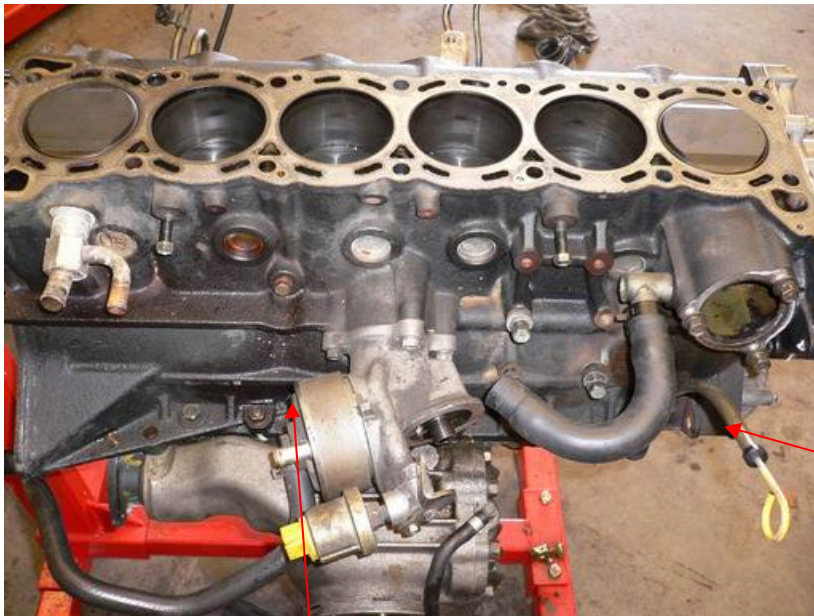
The front mounted dipstick which will have to be removed and plugged.

The rear dipstick mounting hole which will have to be punched out for the rear sump modification
