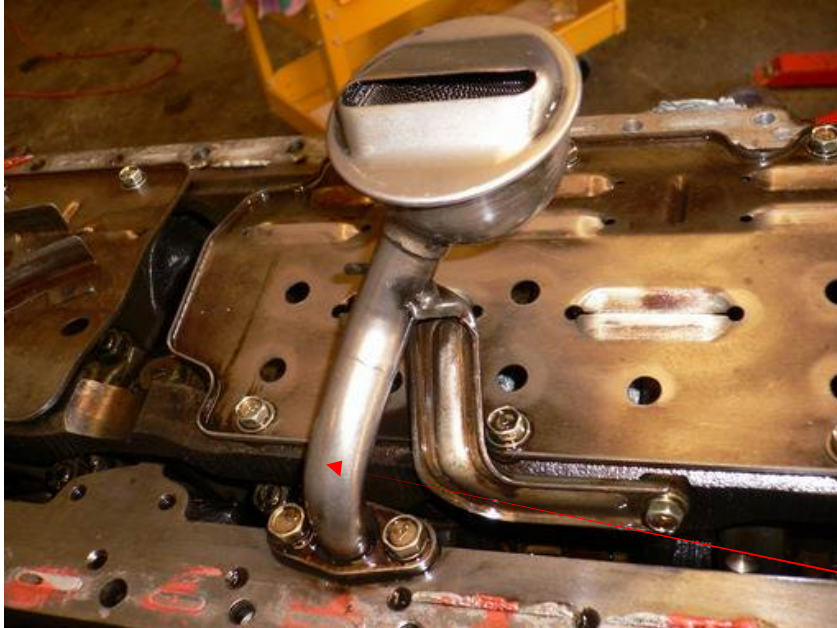
The oil pickup emanating from the front of the motor which will have to be fabricated as a rear pickup

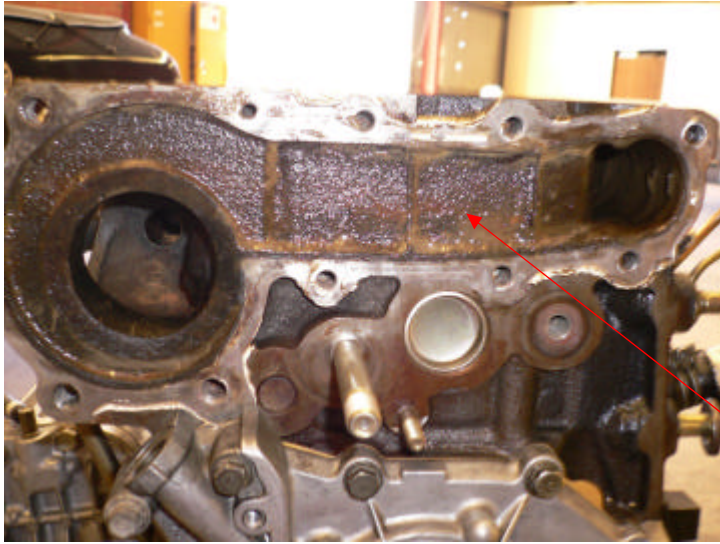
The water pump removed. Block looks good as does the water pump itself but it will be replaced

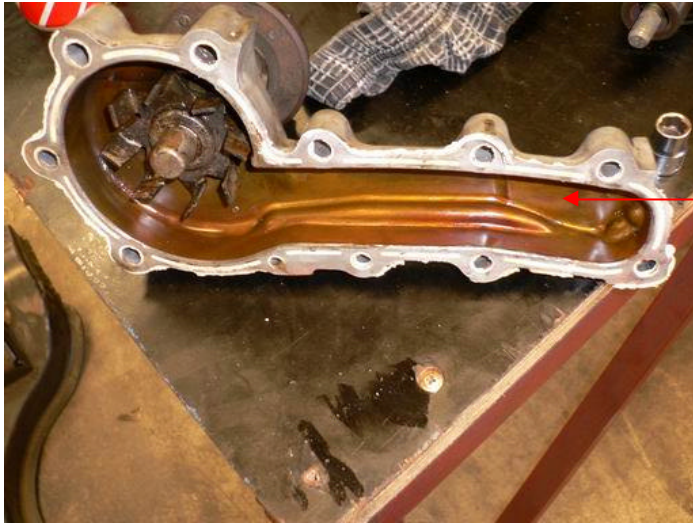
There appears to be a protective coating on the inside of the water pump

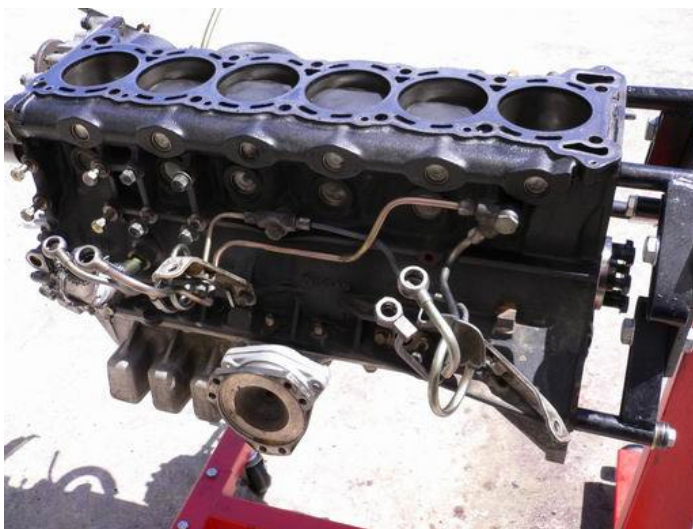
Sump back on temporarily so that the sludge can be flushed out of the block

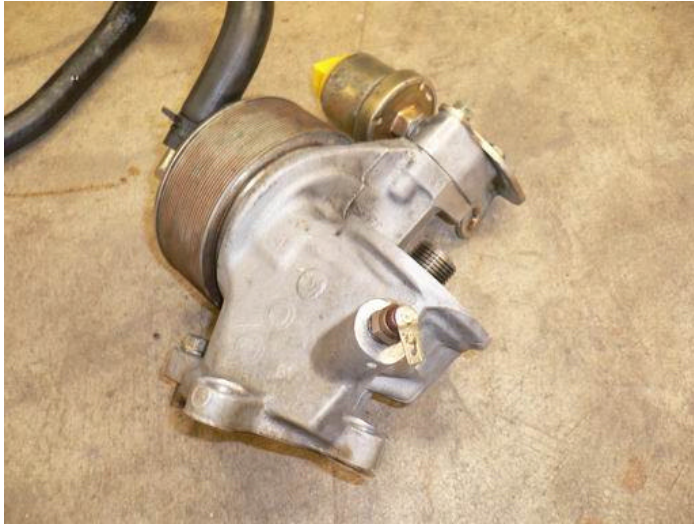
Oil filter & cooler housing. This was put under H<sub>2</sub>O and air pumped through to see if cooler leaked bubbles and therefore was the source of the oil in the water ways – no leaks! So still don't know cause of sludge?!!

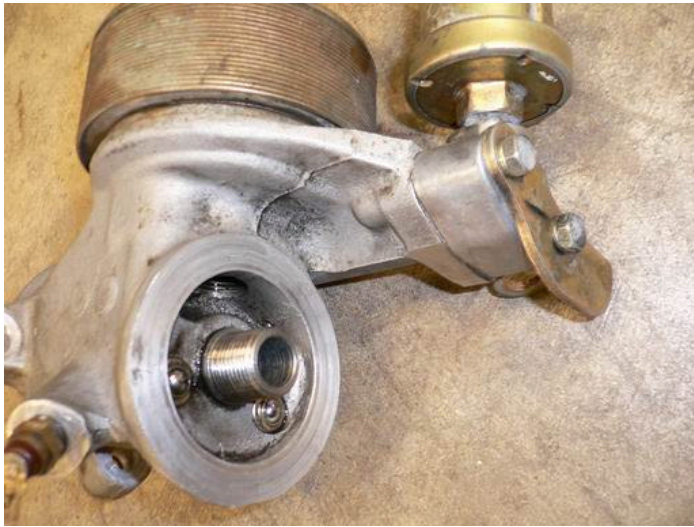
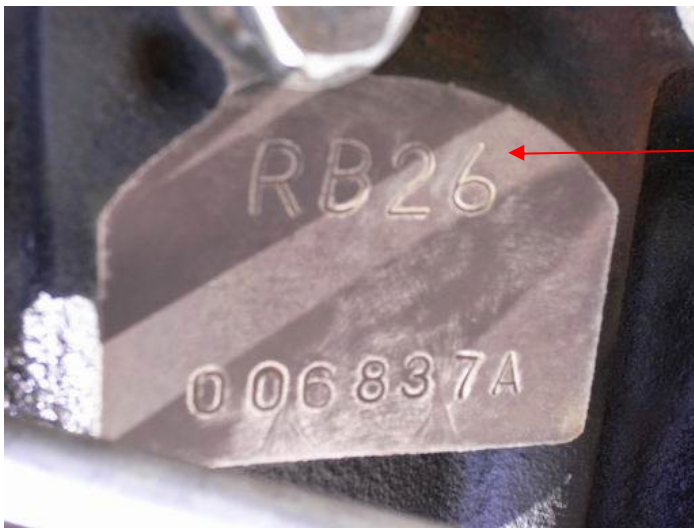
See it is a GTR motor!
